ATTACHMENT A

Photolog

Greenleaf Ledge Dairy, LLC
EPA Inspection May 9, 2019
All photos taken by Ben Atkinson, Agronomist, U.S. EPA
Camera: Ricoh WG-4 and Olympus

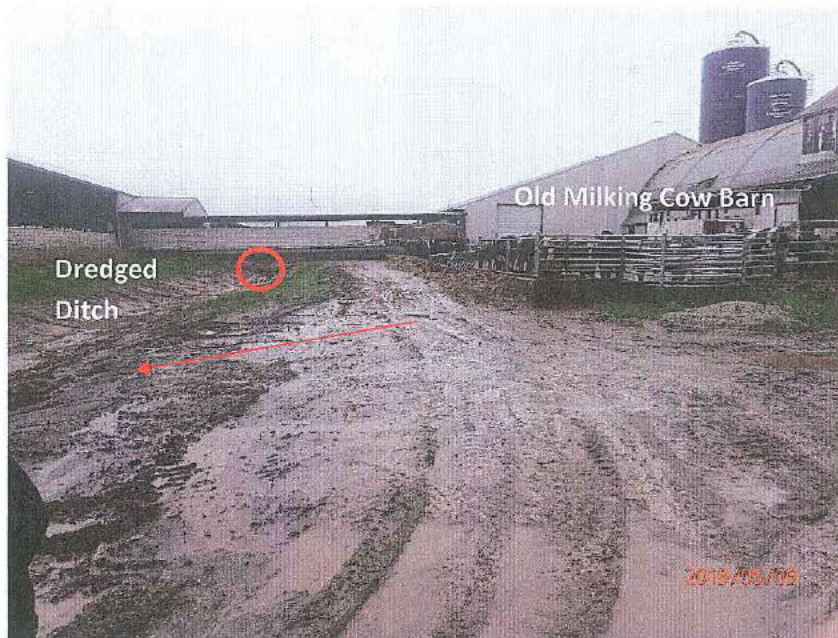
1: P5090001

Description: EPA observed feed and process wastewater flowing into the dredged ditch from the open feedlot attached to the Old Milking Cow Barn. EPA labeled the ditch and direction of flow from the Old Milking Cow Barn. Circled in the photo is a culvert outlet that drains flow from the south side of the barns and under the cow walkway.

Location: EPA is standing on the north side of the access road between the dredged ditch and the Old Milking Cow Barn.

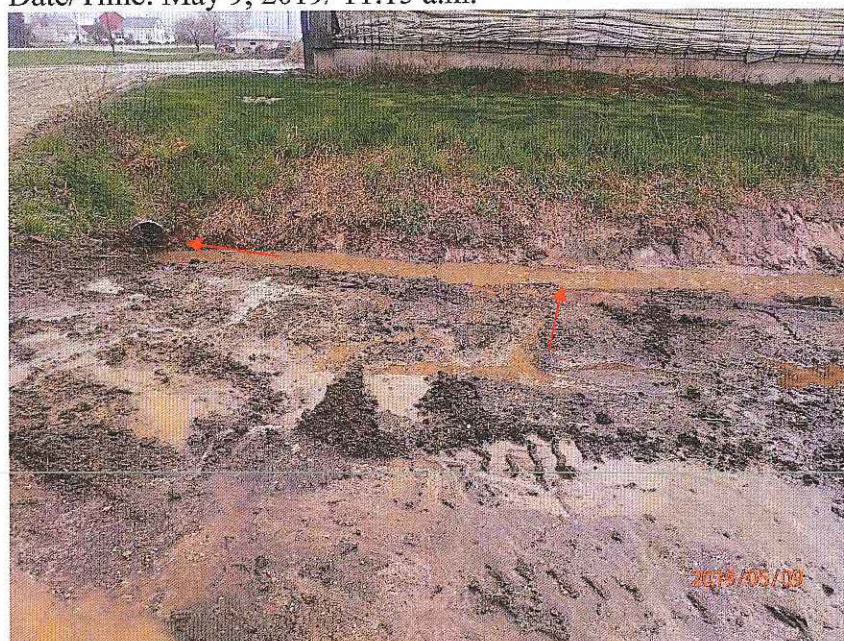
3: P5090003

Description: Close-up of process wastewater from the Old Milking Cow Barn and sediment from denuded areas around the dredged ditch discharging into the dredged ditch and flowing through the culvert inlet to the northeast under the access road.

Location: Northwest side of the dredged ditch.

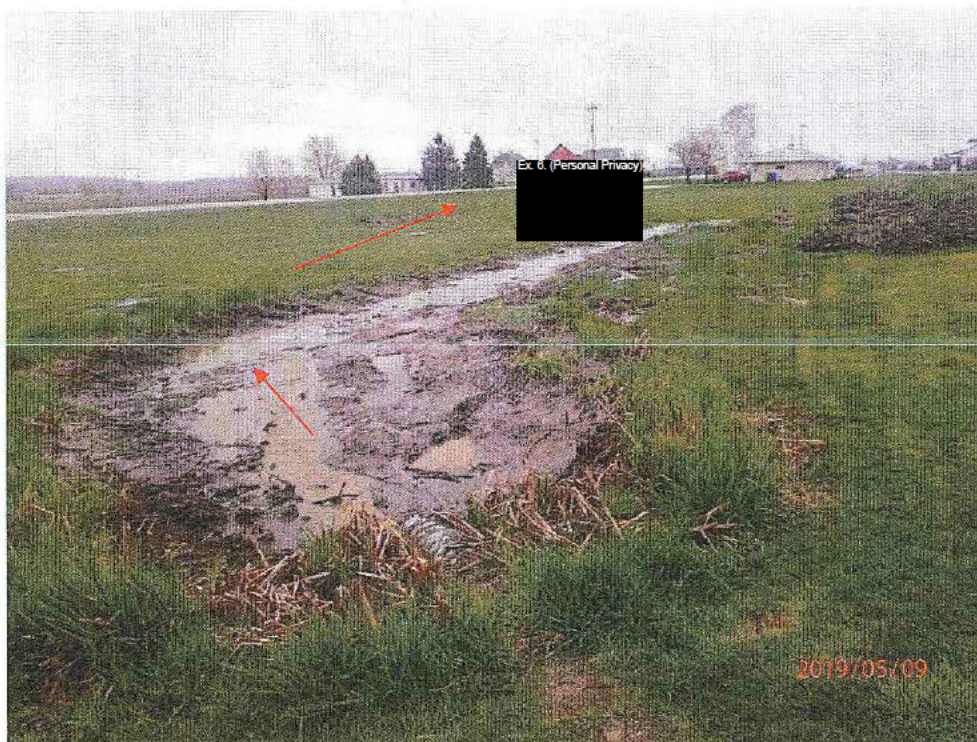
5: P5090005

Description: EPA observed the continuation of flow of the process wastewater within the dredged ditch from between the Old Milking Cow Barn and the Milking and Dry Cow Barn through a culvet under the access road to the northeast toward the roadside ditch. The red arrows show the direction of flow.

Location: North of the access road between the Old Milking Cow Barn and the Milking and Dry Cow Barn.

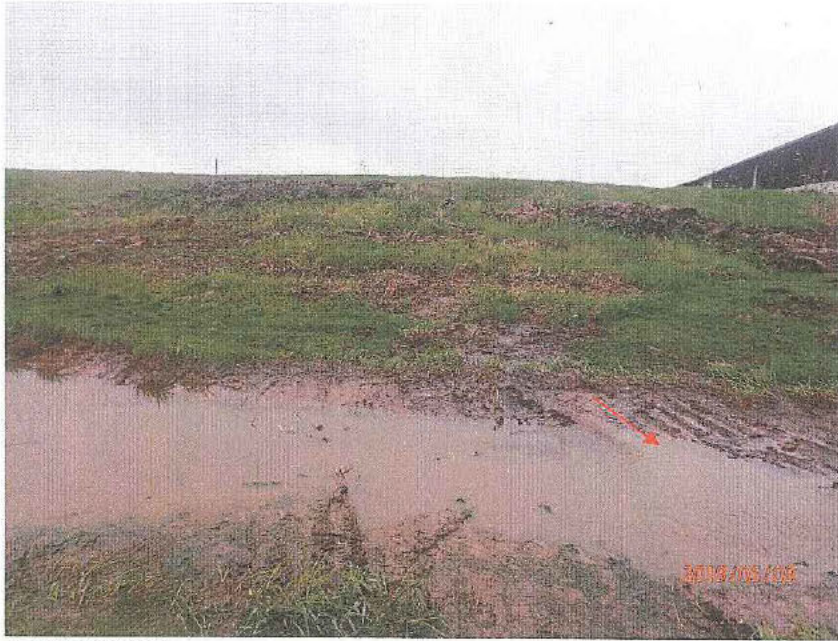
6: P5090006

Description: Additional flow from the crop field to the south of the dredged ditch flows into the dredged ditch. The red arrow shows where EPA observed flow from the field to the south into the dredged ditch.

Location: Northeast of the Milking and Dry Cow Barn on the north side of the dredged ditch.

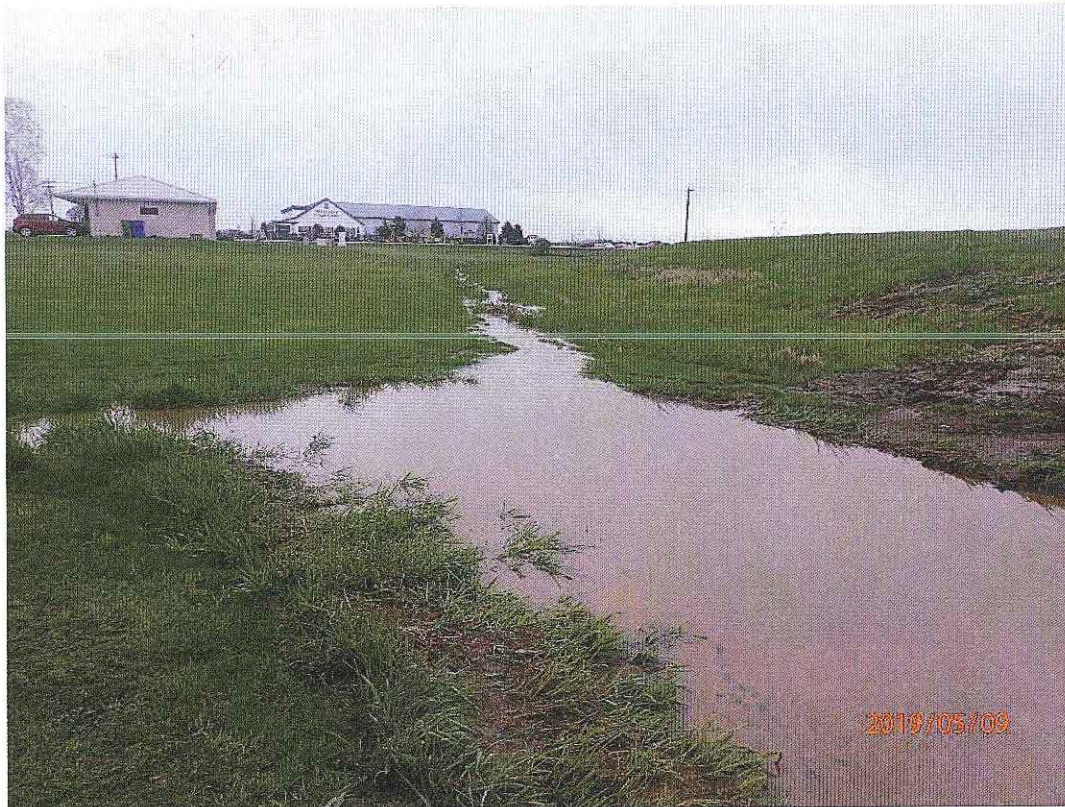
7: P5090007

Description: Runoff from the residence and crop field to the east merges with the flow from the process wastewater in the dredged ditch on Greenleaf's production area and was flowing north toward the roadside ditch.

Location: Northeast of the Milking and Dry Cow Barn on north side of the dredged ditch.

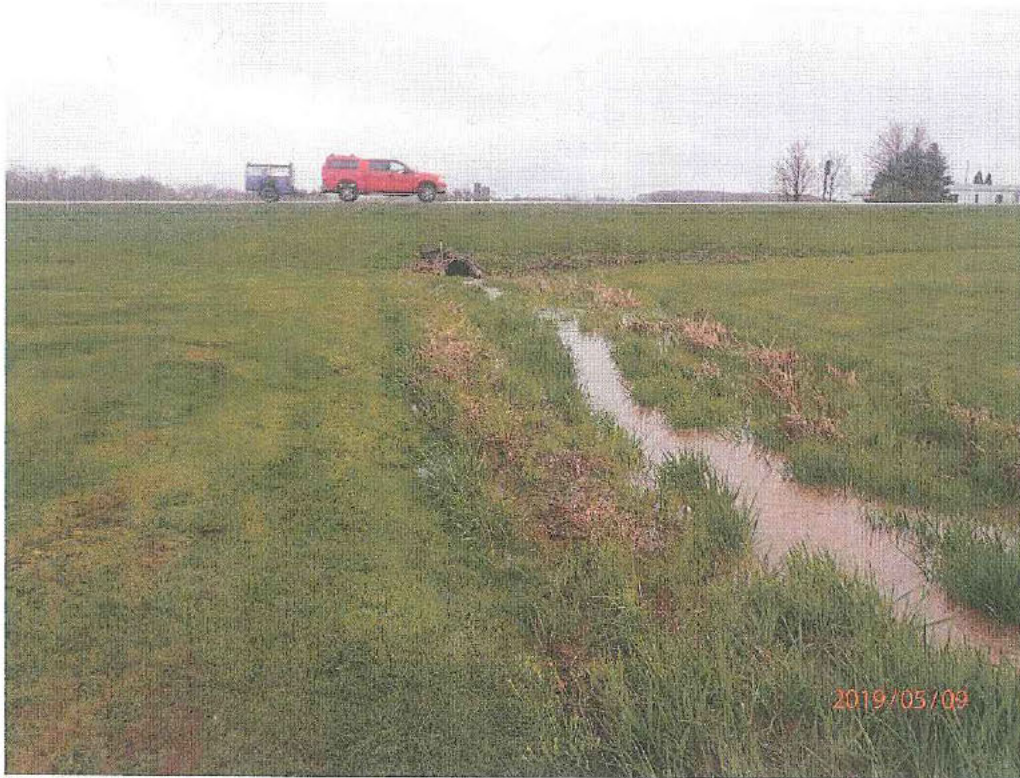
8: P5090008

Description: Runoff from the east was merging with the process wastewater flowing in the dredged ditch from between the Milking and Dry Cow Barn and the Old Milking Cow Barn in Greenleaf's production area flowing north toward the roadside ditch. It flowed through the culvert under Day Street to north side of Day Street and continues to flow through a grassed waterway into the East River.

Location: West side of the merged ditches (ditch from the east and the dredged ditch from Greenleaf).

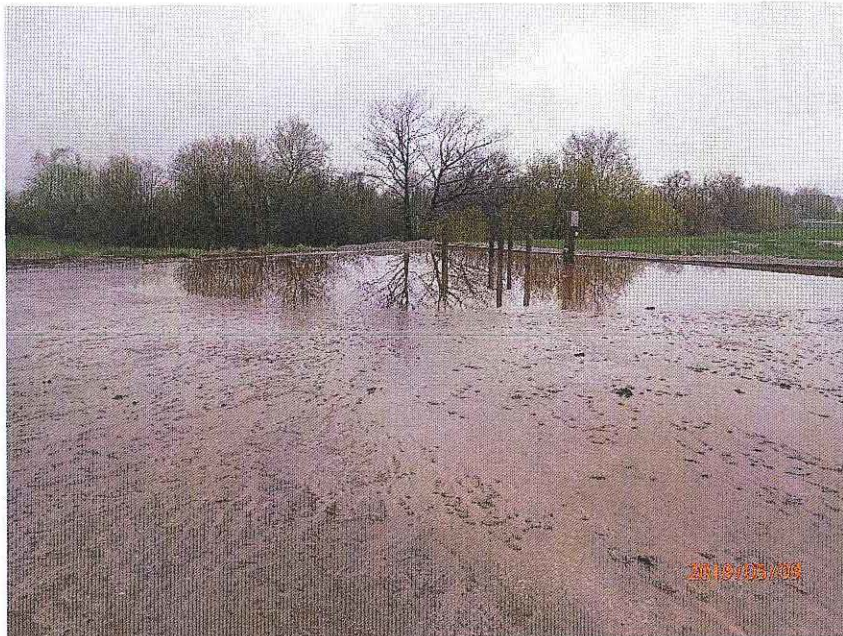
9: P5090009

Description: Process wastewater on the silage feed pad flows to the northwest corner of the silage feed pad and is partially collected in a pit and pumped to the New Pit. The process wastewater not collected in the pit flows into the vegetated treatment area (VTA) to the north.

Location: North side of the silage feed pad.

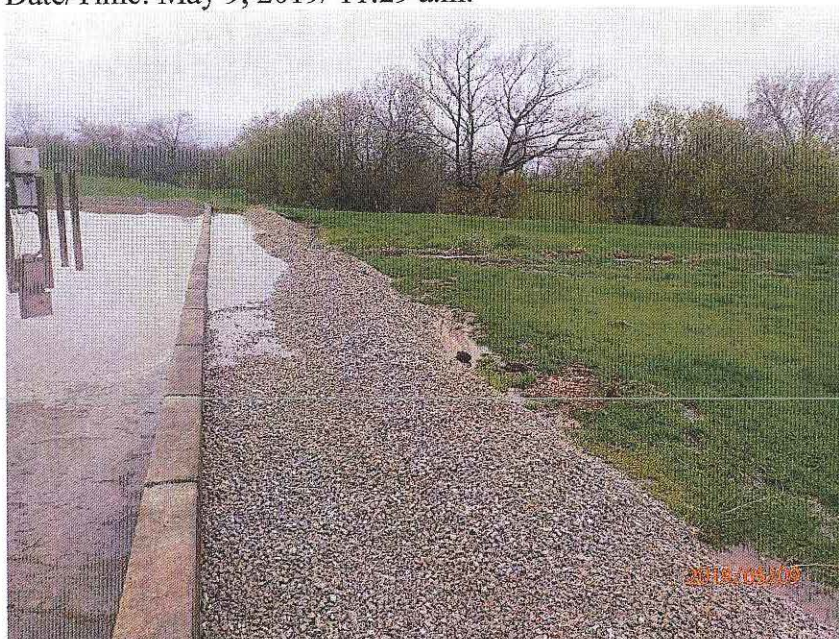
10: P5090010

Description: Spreader bar separating the silage feed pad and the vegetated treatment area.

Location: Northeast corner of the silage feed pad.

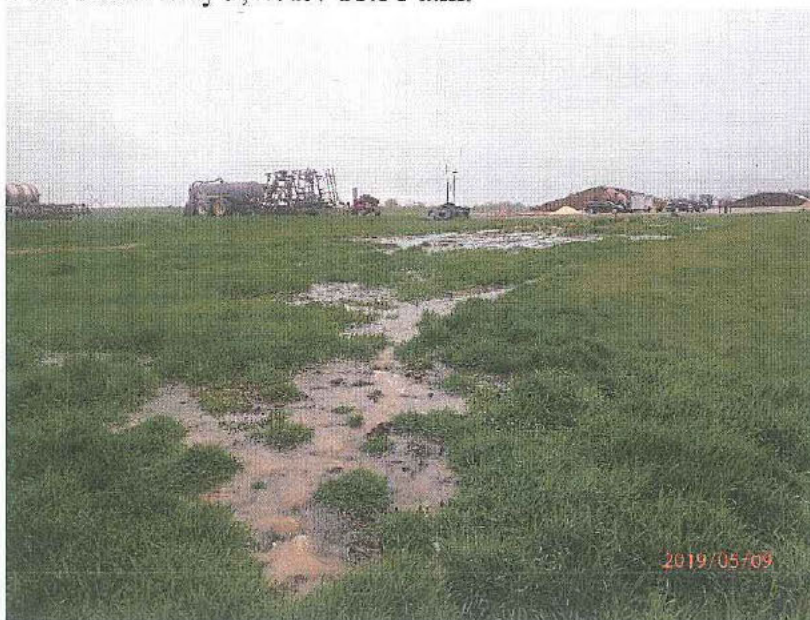
12: P5090012

Description: Northwest corner of the VTA, EPA observed that the process wastewater entering the VTA from the silage feed pad had created a channel that conveyed process wastewater to the north on the west side of the VTA and then west down the embankment and into the unnamed tributary of the East River.

Location: Northwest corner of the VTA.

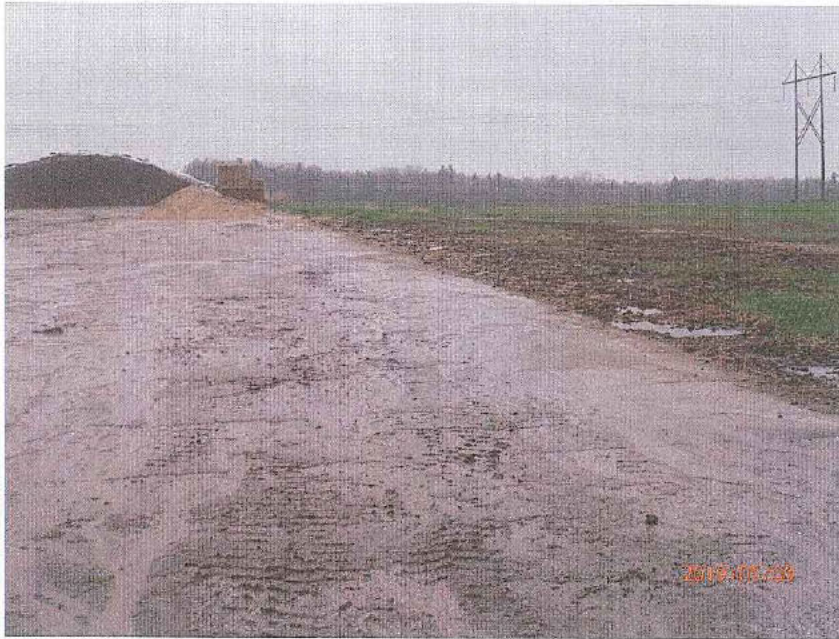
15: P5090015

Description: Northwest side of the silage feed pad, EPA observed exposed feed mixing with stormwater.

Location: Northwest corner of the silage feed pad.

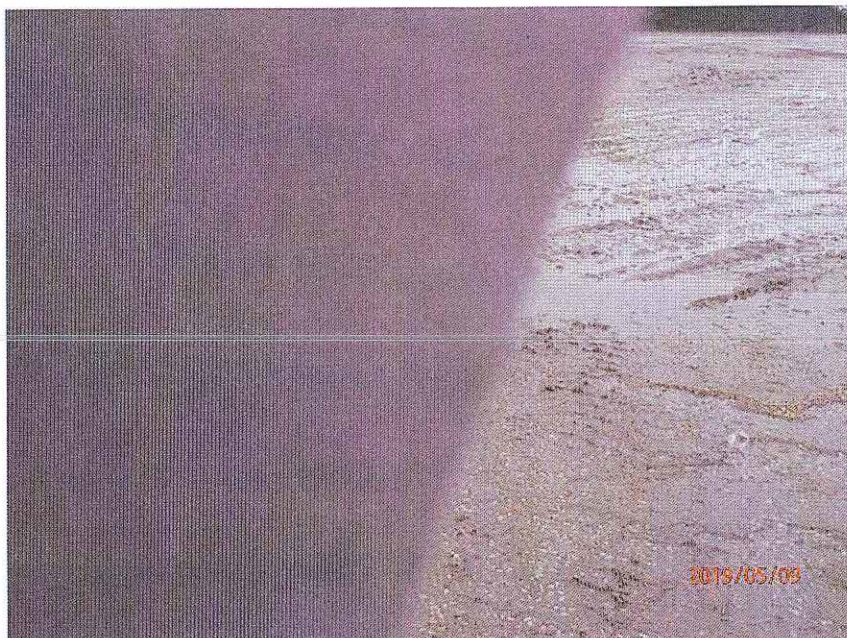
17: P5090017

Description: Supposed to be a close-up of the stormwater mixed with feed on the silage feed pad.

Location: Center of silage feed pad.

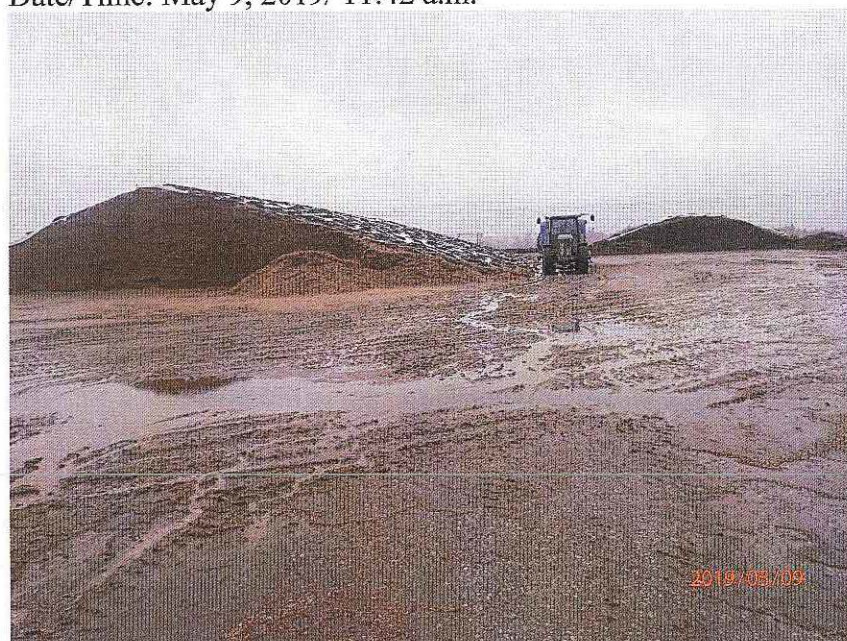
18: P5090018

Description: Open silage and stormwater mixed with feed on the silage feed pad.

Location: Center of silage feed pad.

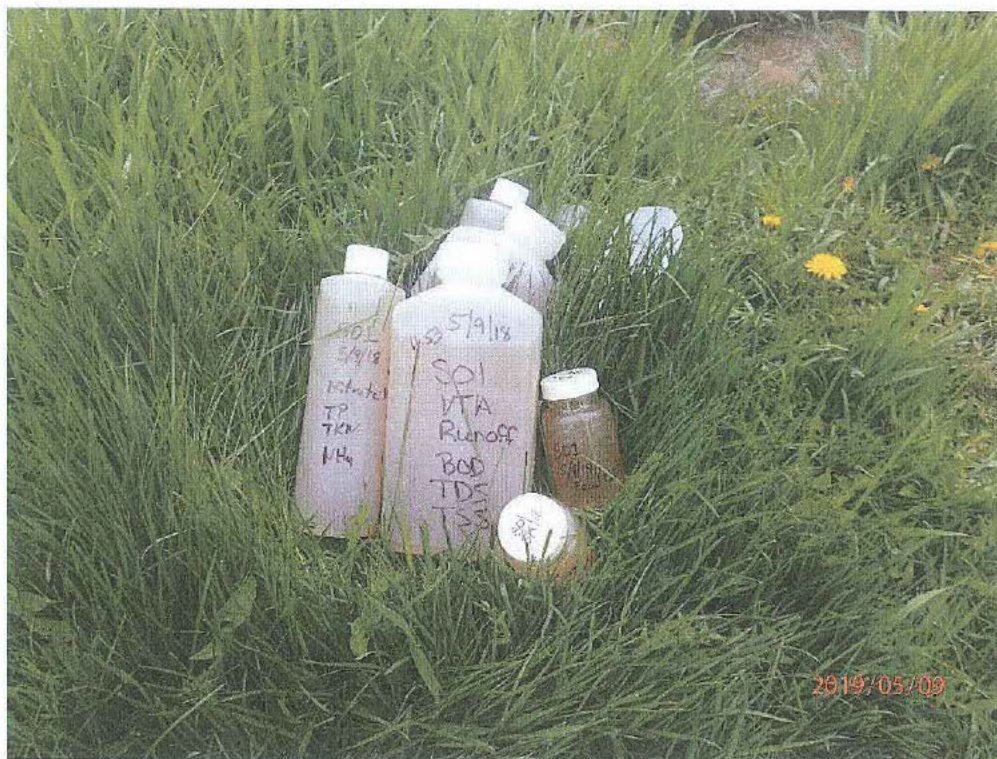
19: P5090019

Description: Sample S01, named "VTA Runoff" was from the eroded channel from the process wastewater flowing through the VTA and discharging into the unnamed tributary of the East River.

Location: Northwest corner of the VTA.

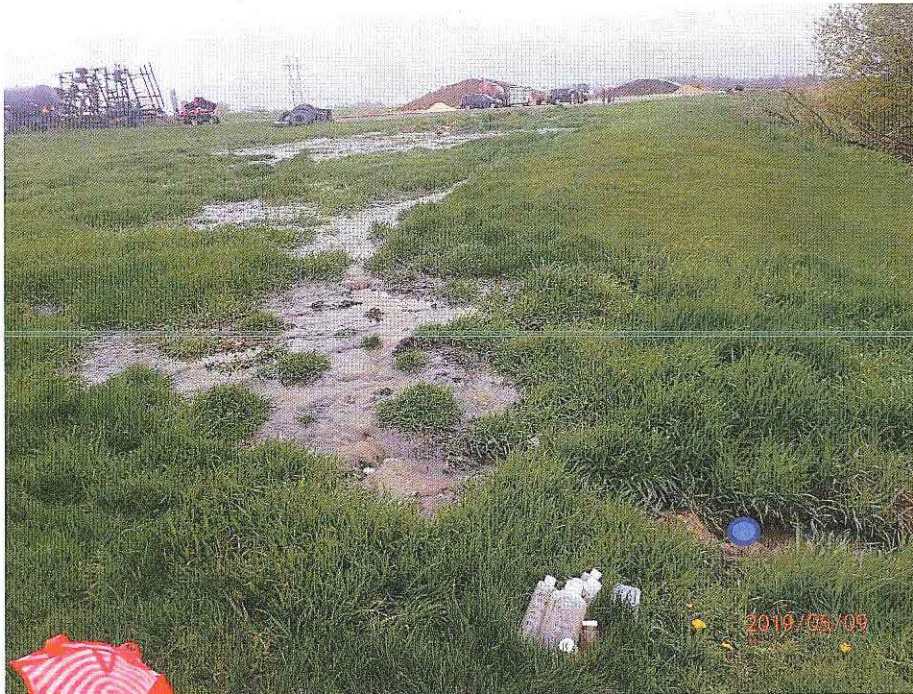
20: P5090020

Description: Northwest corner of the VTA, process wastewater bypassing the pit on the silage feed pad and was flowing through a channel in the VTA toward the embankment of the unnamed tributary of the East River. Blue dot represents approximately where EPA collected sample S01.

Location: Northwest corner of the VTA.

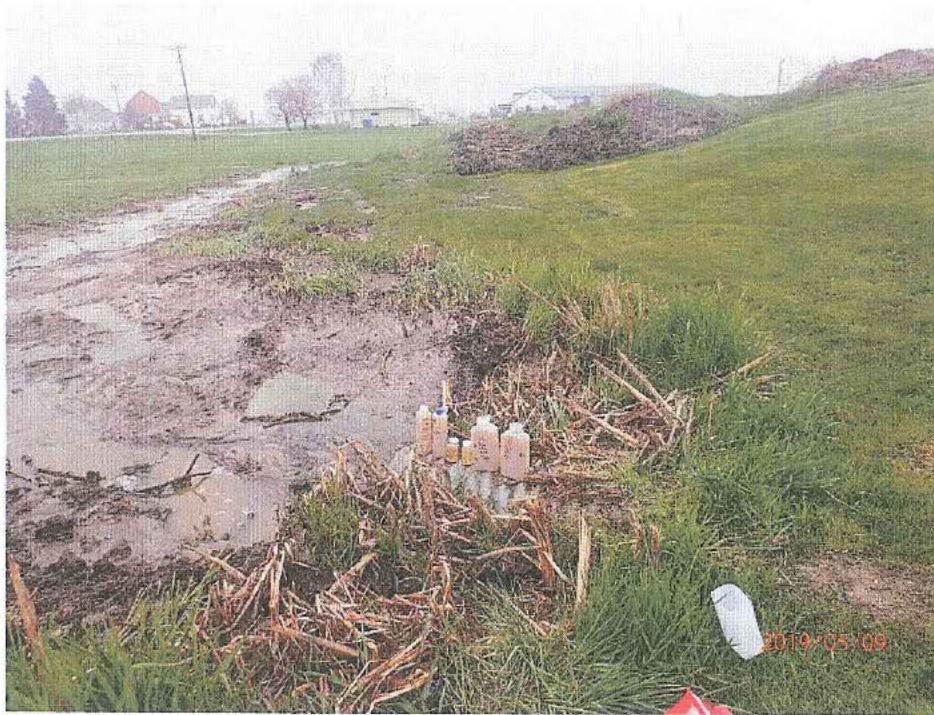
21: P5090021

Description: Sample S02 named "Culvert Outlet" was from the flow coming out of a culvert outlet that conveyed the flow from the dredged ditch between the Old Milking Cow Barn and the Milking and Dry Cown Barn.

Location: North of the access road between the Old Milking Cow Barn and the Milking and Dry Cow Barn.

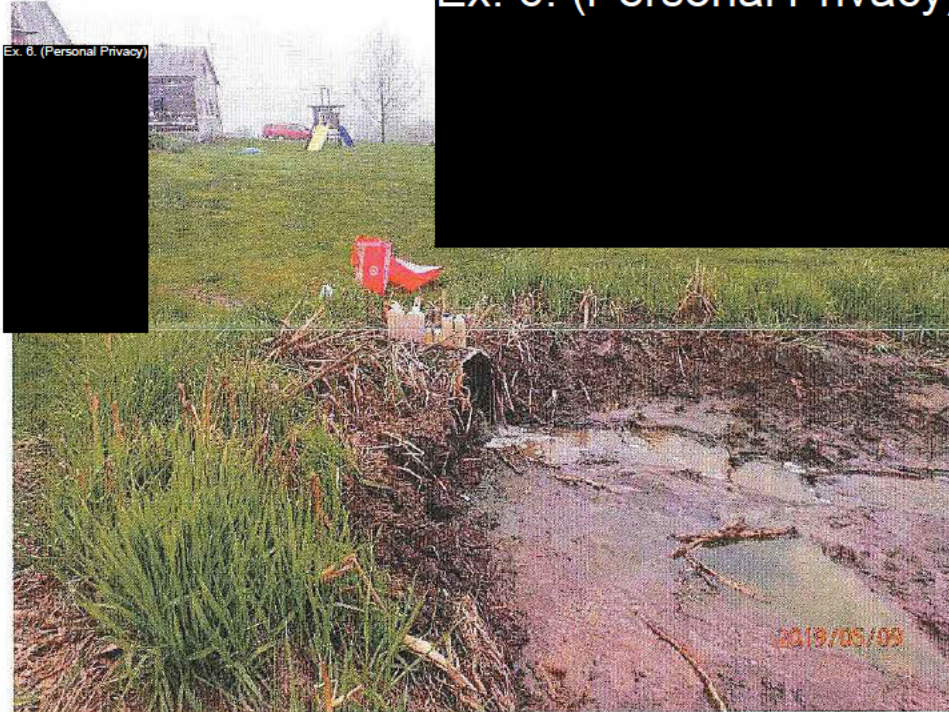
22: P5090022

Description: Sample S02 named "Culvert Outlet" was from the flow coming out of a culvert outlet that conveyed the flow from the dredged ditch between the Old Milking Cow Barn and the Milking and Dry Cow Barn.

Location: North of the access road between the Old Milking Cow Barn and the Milking and Dry Cow Barn.

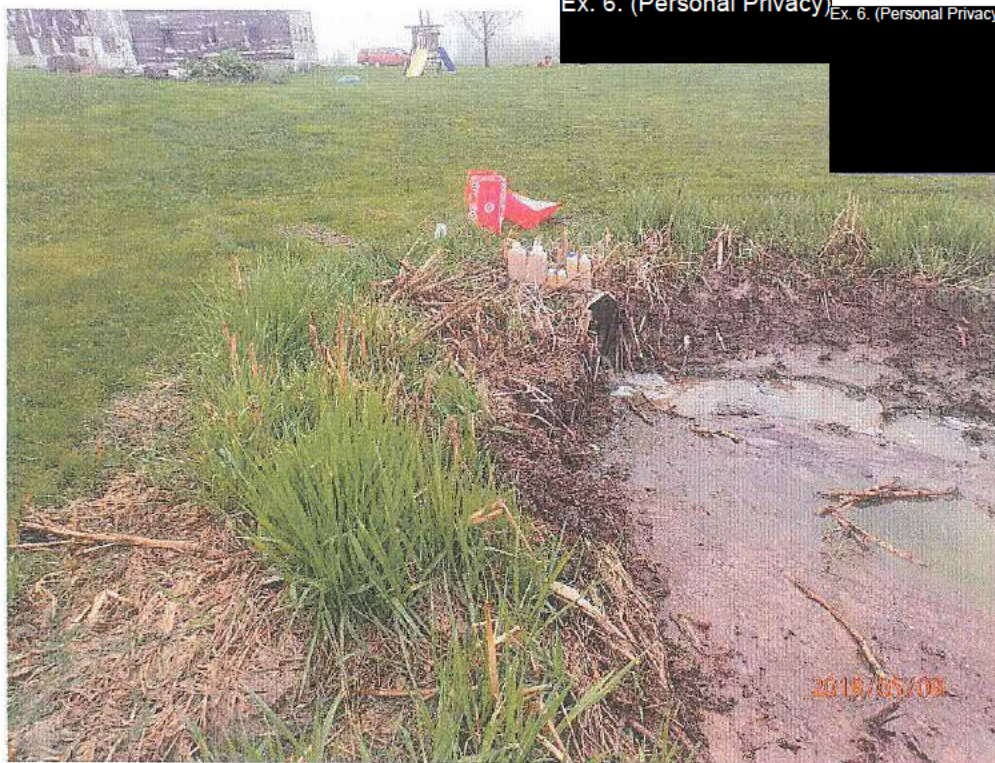
23: P5090023

Description: Sample S02 named "Culvert Outlet" was from the flow coming out of a culvert outlet that conveyed the flow from the dredged ditch between the Old Milking Cow Barn and the Milking and Dry Cown Barn.

Location: North of the access road between the Old Milking Cow Barn and the Milking Cow and Dry Cow Barn.

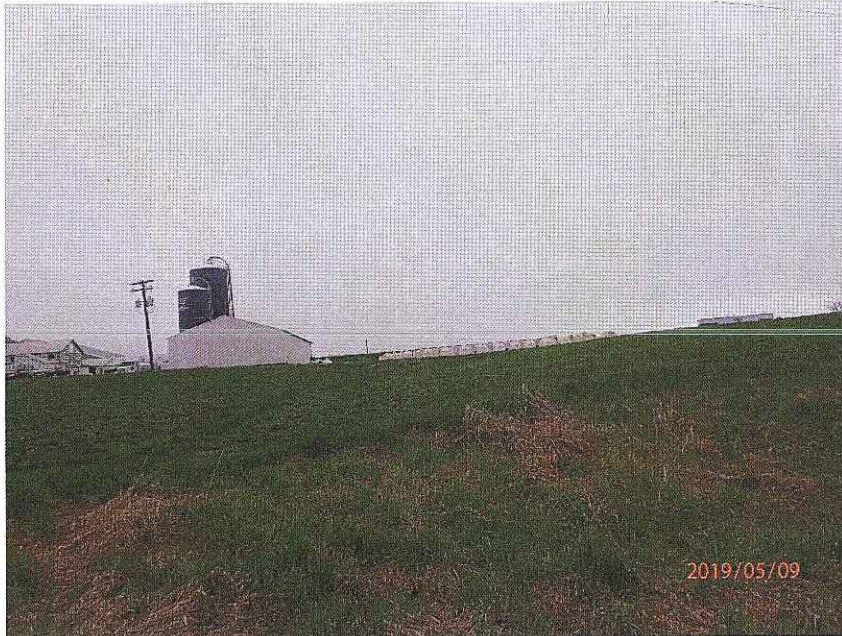
24: P5090024

Description: On the south side of Day Street, viewing the grassed waterway between the alfalfa that conveys the flow from the calf hutch area.

Location: On the south side of Day Street, north of the calf hutch area.

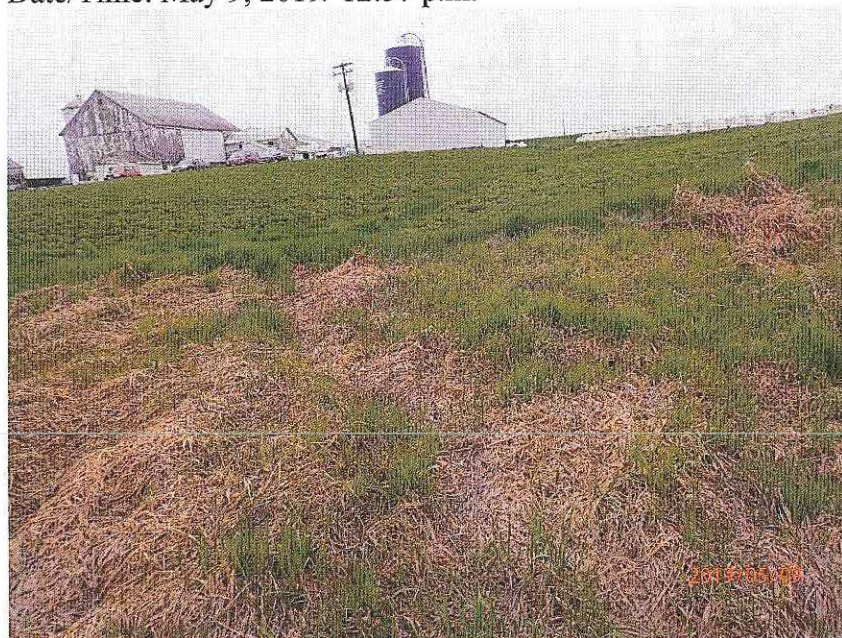
25: P5090025

Description: On the south side of Day Street, showing the flow through the grassed waterway between the alfalfa from the calf hutch area.

Location: On the south side of Day Street, north of the calf hutch area.

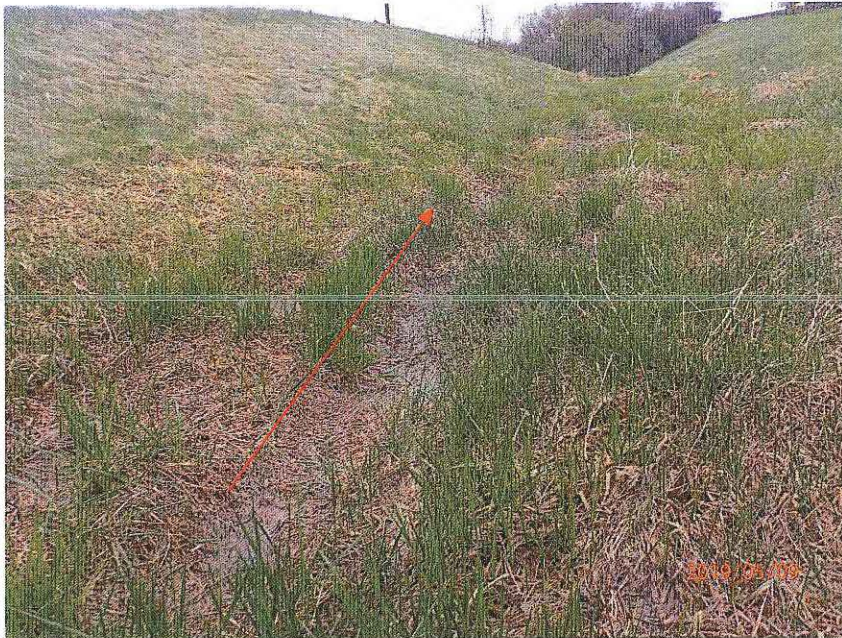
28: P5090028

Description: The process wastewater from the calf hutch area was being conveyed through the grassed waterway into the roadside ditch on the south side of Day Street which was flowing into the East River. Red arrow is showing the direction of flow.

Location: In the roadside ditch on the south side of Day Street.

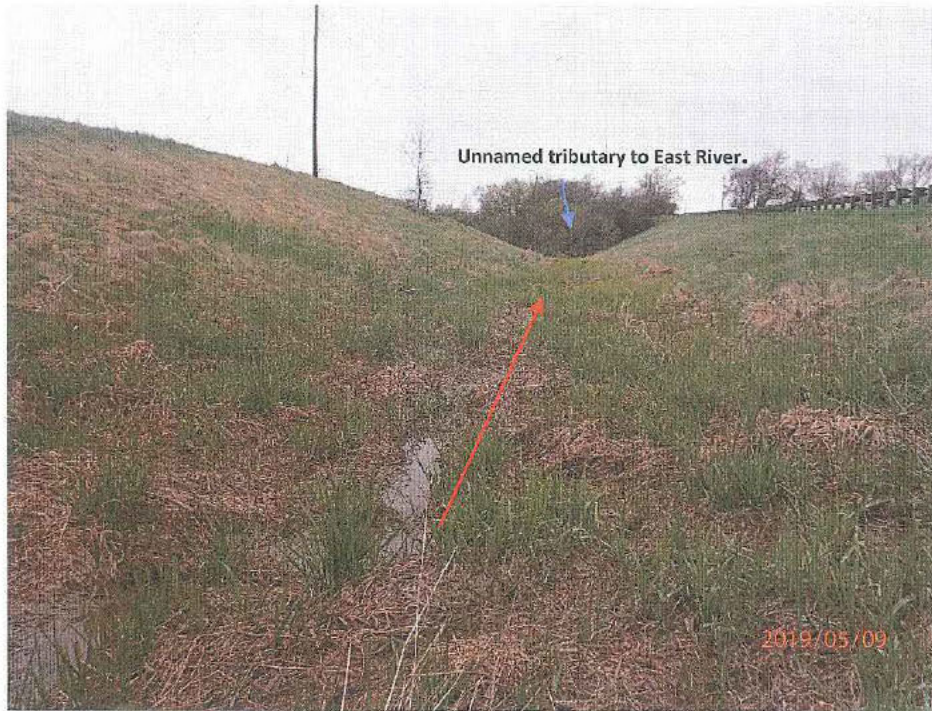
29: P5090029

Description: The process wastewater from the calf hutch area was being conveyed through the grassed waterway into the roadside ditch on the south side of Day Street which was flowing into the East River. Red arrow is showing the direction of flow.

Location: In the roadside ditch on the south side of Day Street.

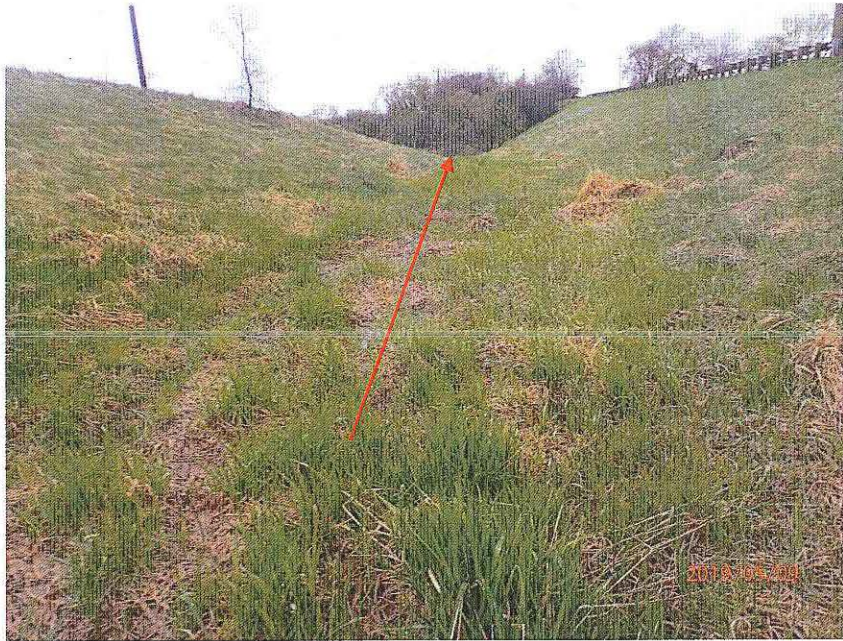
30: P5090030

Description: The process wastewater from the calf hutch area was being conveyed through the grassed waterway into the roadside ditch on the south side of Day Street which was flowing into the East River. Red arrow is showing the direction of flow.

Location: In the roadside ditch on the south side of Day Street.

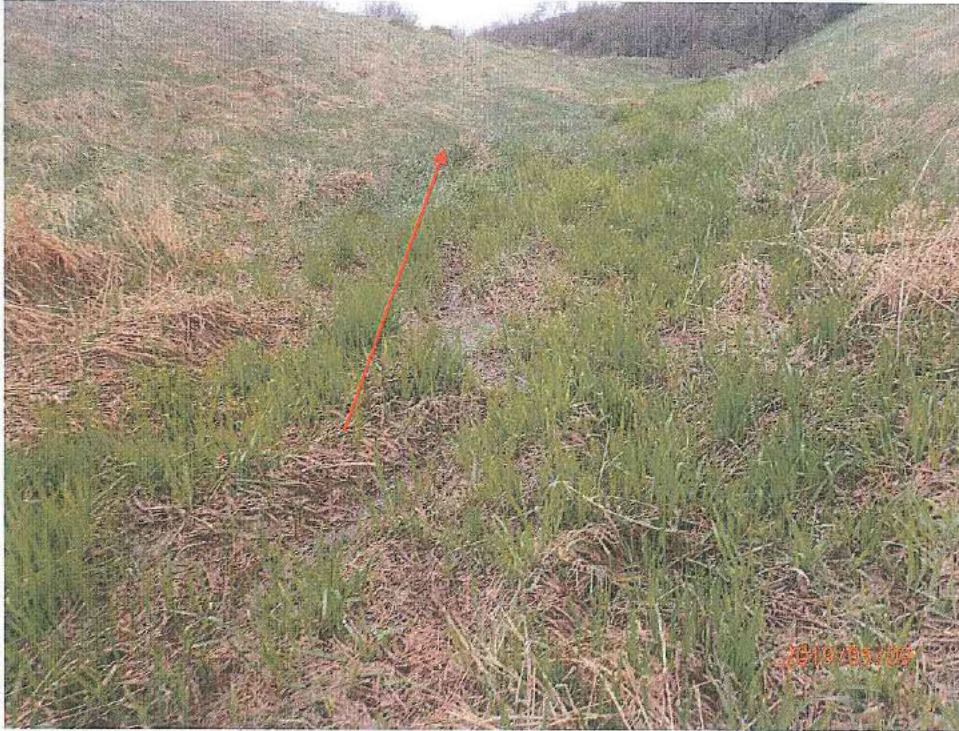
31: P5090031

Description: The process wastewater from the calf hutch area was being conveyed through the grassed waterway into the roadside ditch on the south side of Day Street which was flowing into the East River. Red arrow is showing the direction of flow red arrow shows the direction of flow in the roadside ditch. Red arrow is showing the direction of flow.

Location: In the roadside ditch on the south side of Day Street.

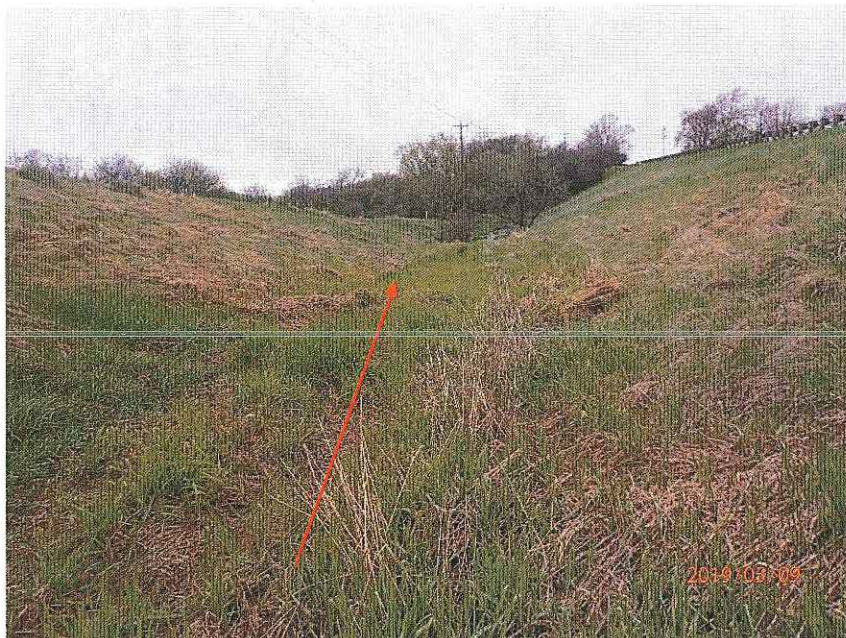
32: P5090032

Description: The process wastewater from the calf hutch area was being conveyed through the grassed waterway into the roadside ditch on the south side of Day Street which was flowing into the East River. Red arrow is showing the direction of flow red arrow shows the direction of flow in the roadside ditch. Red arrow is showing the direction of flow.

Location: In the roadside ditch on the south side of Day Street.

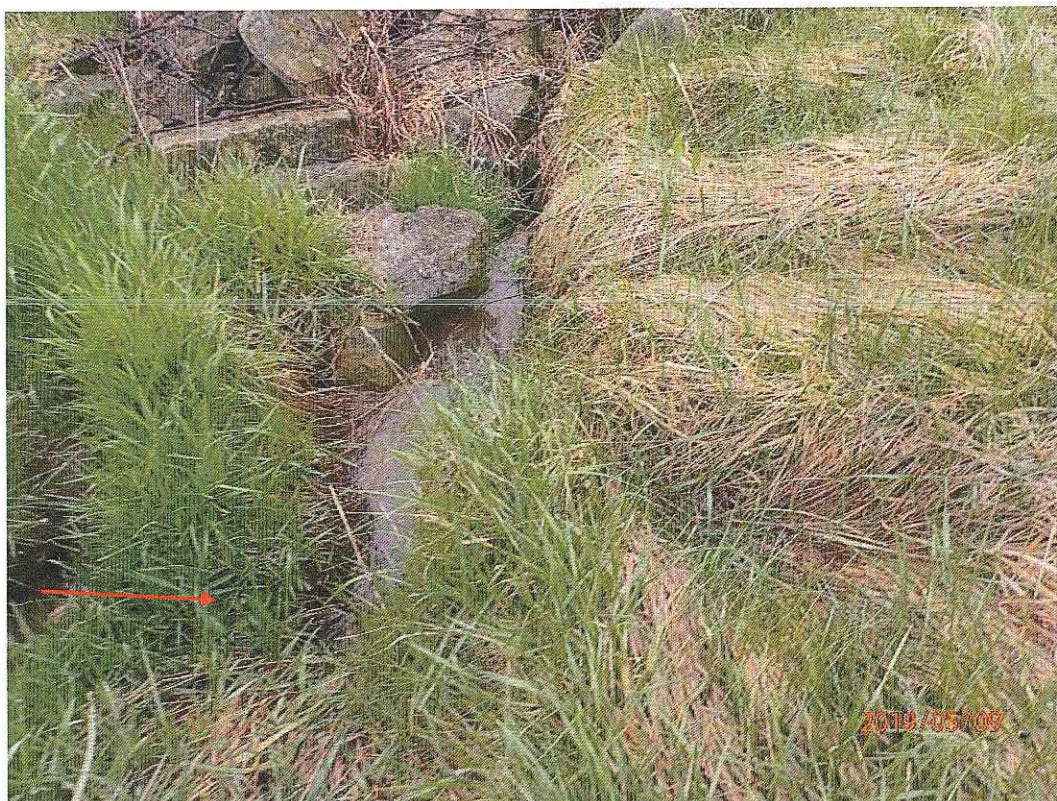
37: P5090037

Description: Flow from the roadside ditch south of Day Street channeled more deeply as it gets closer to the unnamed tributary.

Location: In the roadside ditch on the south side of Day Street.

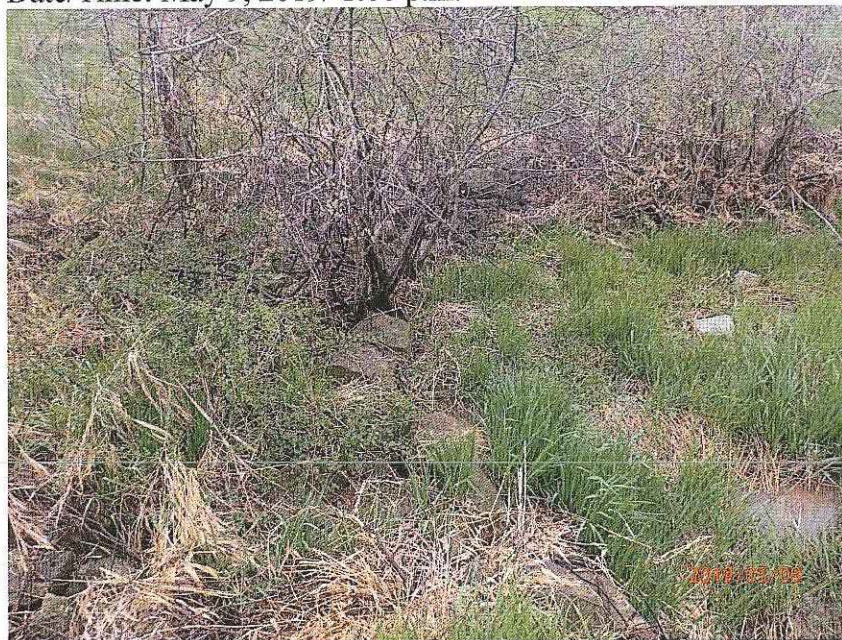
41: P5090041

Description: Roadside ditch discharging into the unnamed tributary.

Location: At the confluence of the roadside ditch and the unnamed tributary.

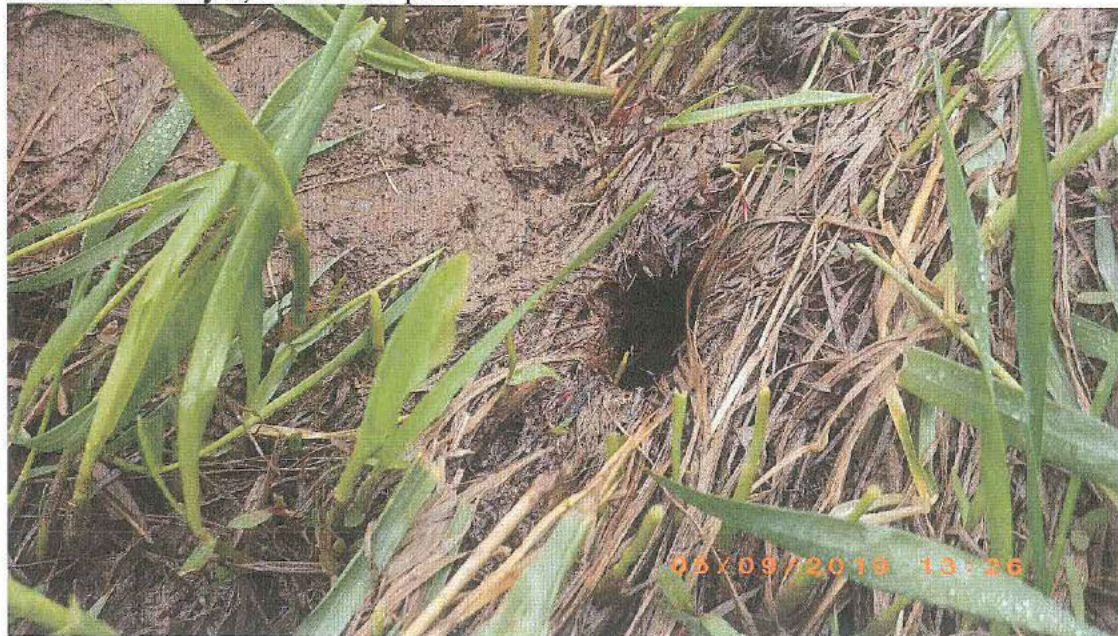
49: RIMG0099

Description: Rodent hole near the culvert outlet discharging into the grassed waterway from the calf hutch area.

Location: Culvert outlet north of the calf hutch area.

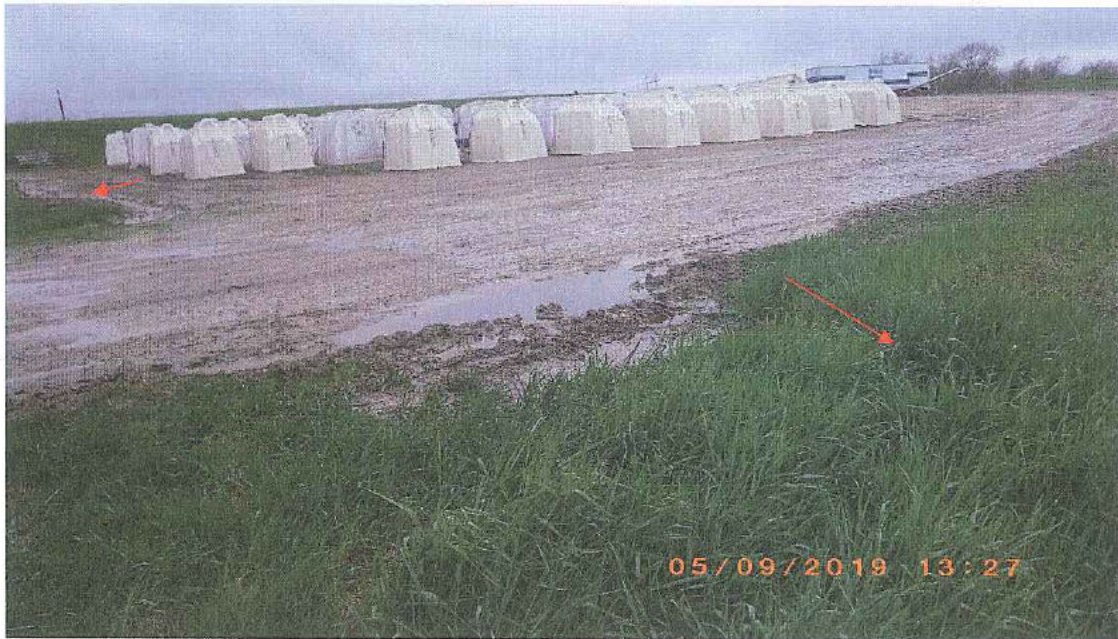
52: RIMG0102

Description: Process wastewater from the calf hutch area surface flows to the north and flows to the east into a culvert inlet into the grassed waterway. Red arrows show the direction that the process wastewater from the calf hutch area flows to a tile inlet and overland flow into the grassed waterway.

Location: Culvert outlet north of the calf hutch area.

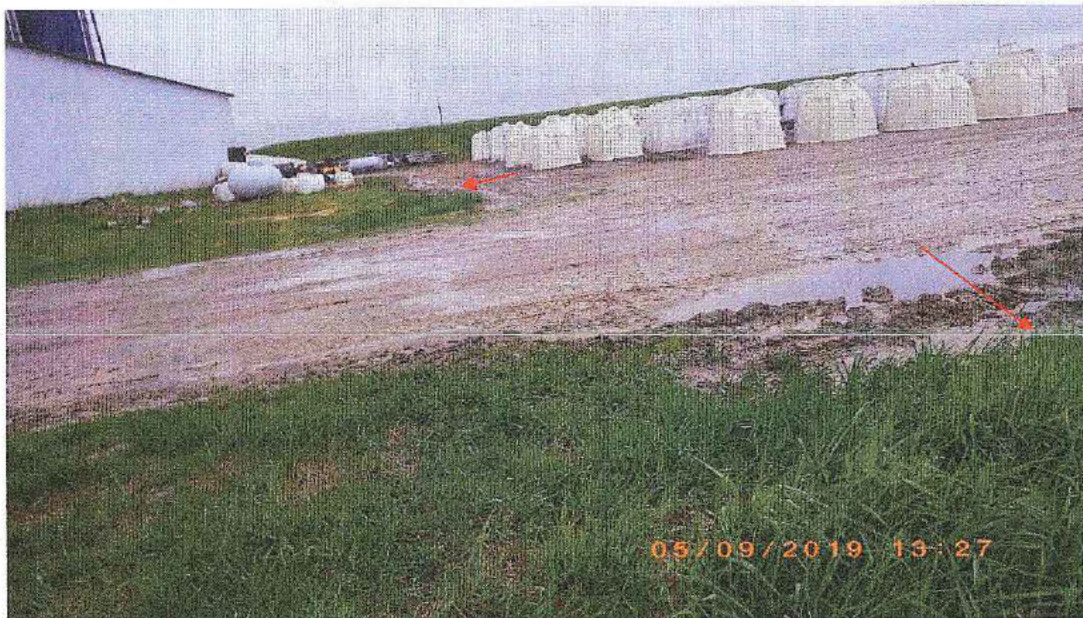
53: RIMG0103

Description: Process wastewater from the calf hutch area surface flows to the north and flows to the east into a culvert inlet into the grassed waterway. Red arrows show the direction that the process wastewater from the calf hutch area flows to a tile inlet and overland flow into the grassed waterway.

Location: Culvert outlet north of the calf hutch area.

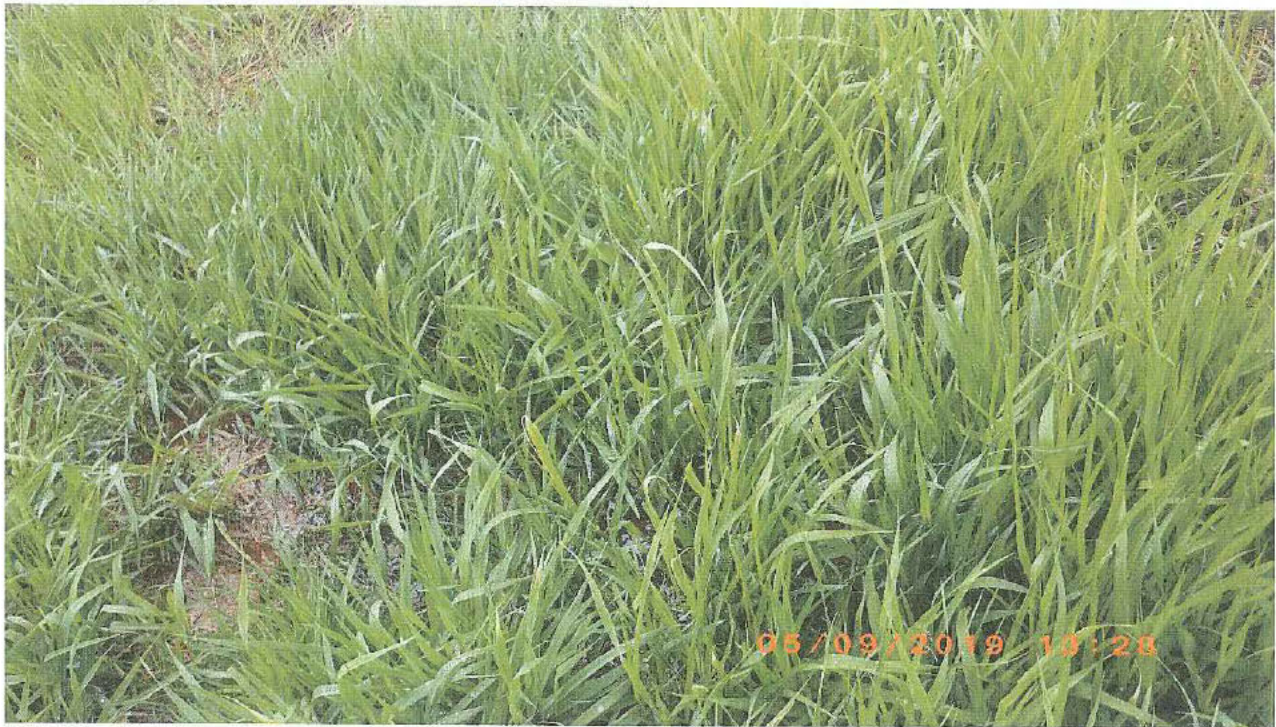
55: RIMG0105

Description: Process wastewater from the calf hutch area flows through the grassed waterway to the north into the roadside ditch.

Location: Culvert outlet north of the calf hutch area.

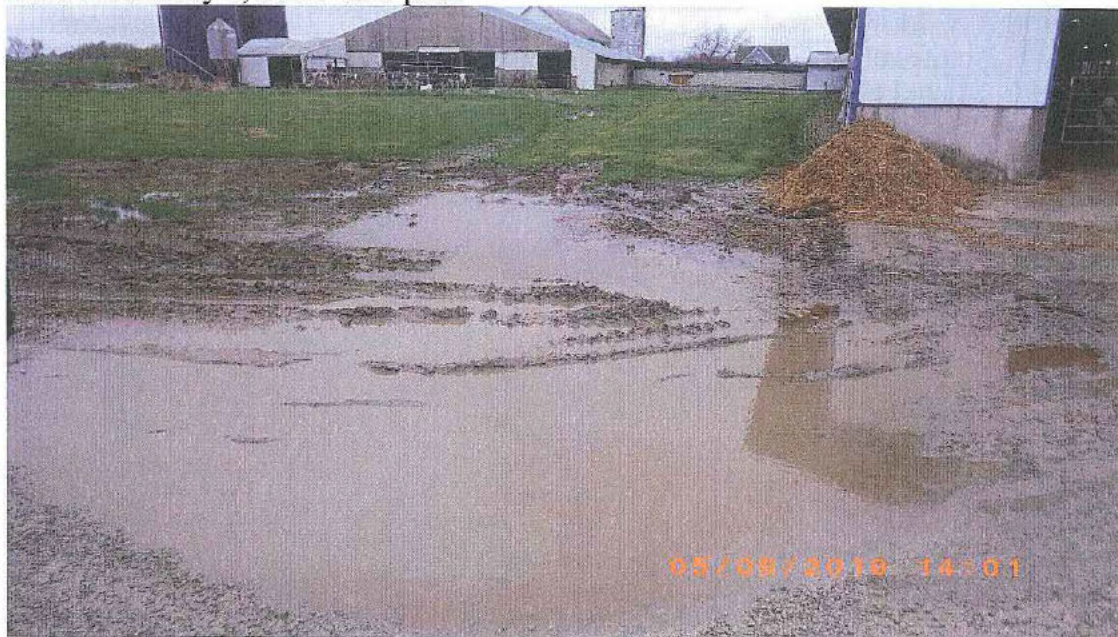
62: RIMG0112

Description: Used bedding outside the Milking and Dry Cow Barn mixing with stormwater and flowing north.

Location: Southwest corner of the Milking and Dry Cow Barn.
